ANALYSIS OF FA 10264 REIL AND DME WATER PROBLEM

STATEMENT OF PROBLEM:

Several REIL's and a number of DME control units have been identified to have a major water problem that contributes to failures of the electronics and out of service calls on the systems. This problem is reported nation wide.

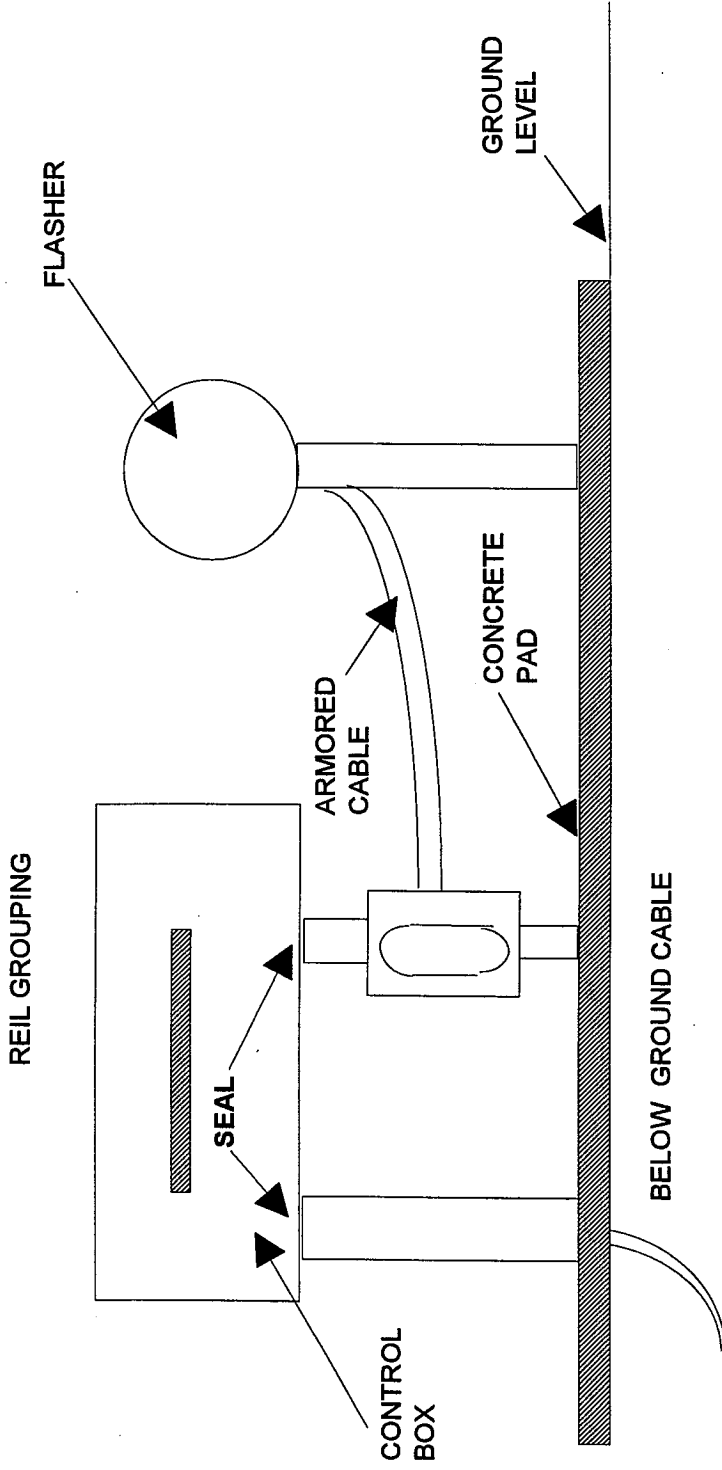
The control box resembles an 18 inch by 18 inch by 8 inch high aluminum suitcase mounted horizontally on two pipe supports. The aluminum cover is hinged at the back and is about eight inches high. When the control box is opened, the electronics which are stacked six inches high are visible. They are mounted on a single horizontal aluminum sheet about 18 by 18 inches which sits inside the enclosure. This plate in turn is mounted by means of screws and one inch spacers to a cast aluminum base plate which is the bottom of the unit.

Two three inch diameter pipes which are screwed into the base are the structural supports holding the control box about 24 inches off the ground. See attached sketch in Excel 4.0 (Figure 1). The pipes also function as conduit, routing cables from the control box to the adjacent flasher (about 3 feet to the side of the control box) and bringing power into the location through trenched access.

- Second the 2 each 3 inch diameter pipes entering the box from below will allow entry of moisture from below. Again the temperature cycling will 'wick' moisture into the enclosure. These were examined in detail to see how they influenced the system. The far left pipe goes deep into the ground and routes the power to the complex. It is assumed that it consists of cable directly in contact with the soil below ground level - no PCV pipe. Both the two remaining pipes - the other support for the control box and the support for the flasher are mounted to the concrete pad using frangible couplings. It is assumed that they don't enter the ground. Moisture can enter through the pipe - to - concrete surfaces - no gaskets visible, through the armored cable and through various access ports - all have intact gaskets. Any moisture drawn into the flasher collage can be drawn into the enclosure through the right hand 3 inch pipe.

Next the two 3 inch pipes have to be sealed so they don't act as a viaduct for bringing moisture into the enclosure. DUCT SEAL a commercial product which the technicians have in the repair van is the recommended fix. This compound is similar to modeling clay, it is used in most of the commercial environmental labs to seal entry to a wide range of environmental tests. It is flexible and can be readily removed in a matter of minutes. Silicone rubber was considered but the cables coming through these pipes have to be accessed so silicone rubber is not a viable solution. The technician indicated that if the flasher fails the assembly comes with the cable as an 'umbilical cord' and the cable and the flasher have to be replaced - not a good design (a possible opportunity to put in an ECP for cost saving).

The control box has to be opened and the interior plate holding all the components has to be removed. 4 screws hold the plate, 4 hold the large transformer and another 4 hold another assembly. Other screws may be involved in this removal. Then the two 3 inch pipe mouths are accessible. DUCT SEAL is to be pushed into the opening to make sure it is sealed (removal is easy; fingers can extract the material which doesn't harden even after years of service - a tool can be designed to hasten removal if deemed appropriate). It was originally thought to access only the pipe entering the ground but that approach is more trouble than it is worth. Sealing both is much smarter.

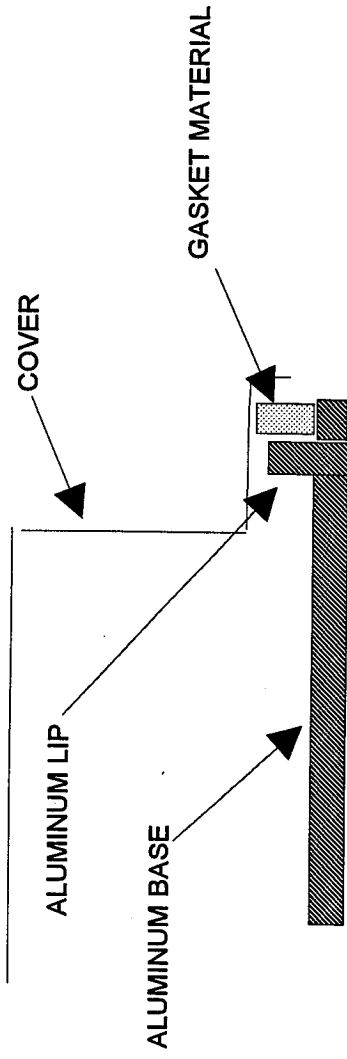
Gaskets surround the aluminum lip to act as a seal against water entry. The design requires that the gasket material initially protrude above the aluminum lip so the flexible material can be compressed and act as a good seal. See attached sketch in Excel 4.0 (Figure 2). Unfortunately in the out of service unit, the gasket is mounted below the lip so

it is ineffective for a good deal of the circumference. This is not a good design as there is no positive compression of the gasket under all conditions.

- First the inoperable gasket identified above will allow moisture to be drawn into the box when the REIL turns on and off causing alternate heating and cooling (the box 'breathes' - heat expands the air driving it out of the box; cooling causes a drop in pressure drawing air into the box). This will draw in moisture during heavy fog or rain conditions or if there is a lot of standing water on the surface.

COVER SEALING CONCEPT GASKET TO BE HIGHER THAN BASE LIP

First the gasket for the cover on the failed unit should be replaced so that the gasket rises above the aluminum lip.
